Floods of August 21–24, 2007, in Northwestern and North-Central Ohio

Open-File Report 2009–1094

By David E. Straub, Andrew D. Ebner, and Brian M. Astifan

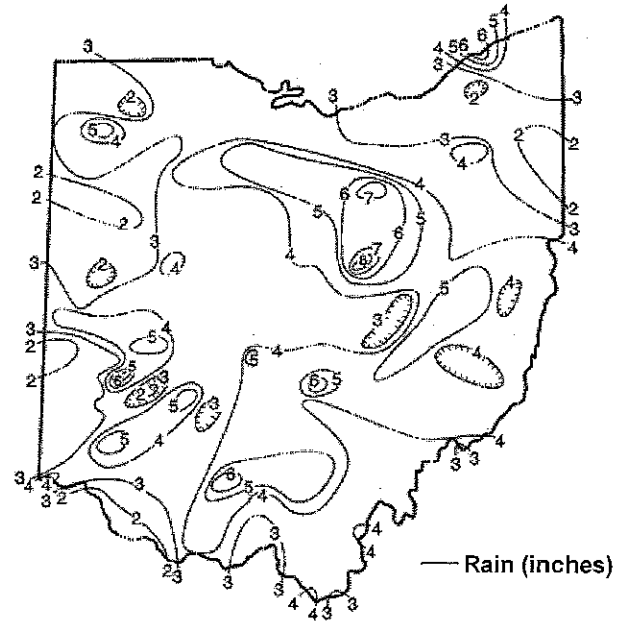
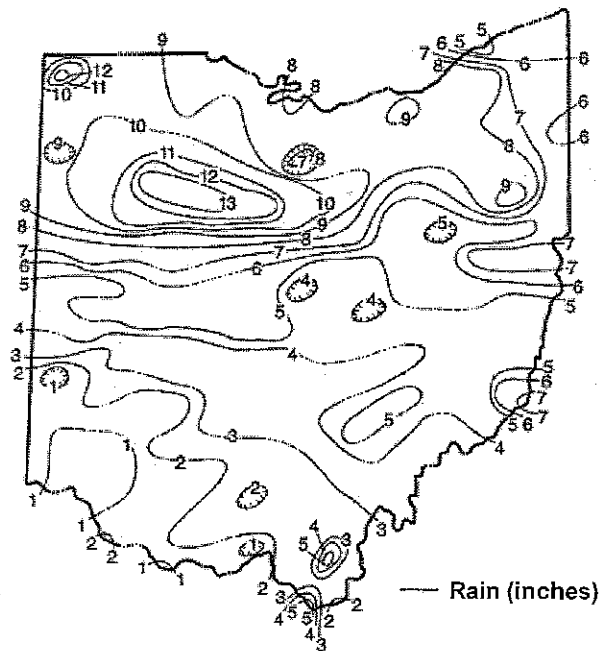
Figure 3. Regionally averaged monthly total precipitation and percentage of normal precipitation for the 10 climatic regions and the monthly hyetograph of Ohio by National Weather Service for July and August 2007 (from Kirk, 2007c, d).

also received 1 to 3 in. between July 17 and July 28. During late July, the greatest amount of rain fell in an area from northwestern to east-central and southeastern Ohio (Kirk, 2007c). The 10 climatic regions of Ohio, the average precipitation and percent of normal of each region, and an isohyetal plot of the total precipitation for July are shown in figure 3A.

The “Monthly Water Inventory Report” for August (Kirk, 2007d) includes the rainfall during August 19–25 in the monthly totals. The precipitation for August was above normal for most of Ohio except the southern part of the State (fig. 3B). The statewide average was 5.75 in., 2.31 in. above normal. Precipitation was heaviest in the Northwest climatic region with a total of 10.10 in., which was 6.91 in. above normal. August 2007 was the seventh-wettest August during 125 years of record for the State as a whole. Regionally, this was the wettest August of record for the Northwest, North-Central, and Northeast climatic regions of Ohio. Upper Sandusky (Wyandot County) reported 13.77 in. and Pandora (Putnam County) reported 13.61 in. of precipitation in August. Radar estimates show that localized areas in Wyandot County probably received more than 15 in. of rain for the month, and unofficial reports indicated more than 17 in. (Kirk, 2007d).

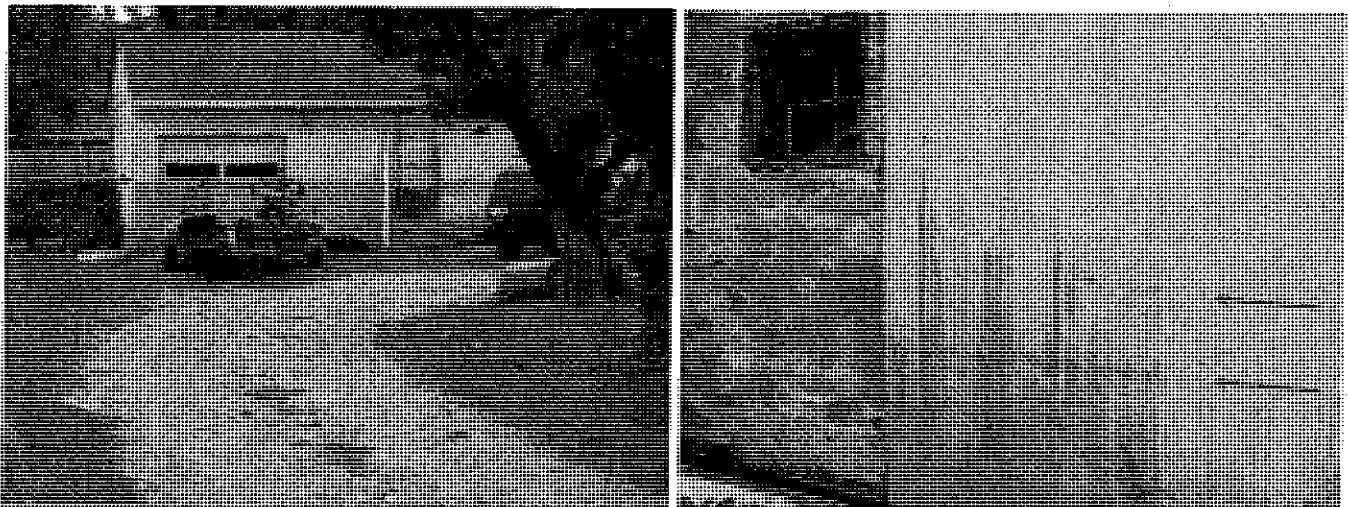
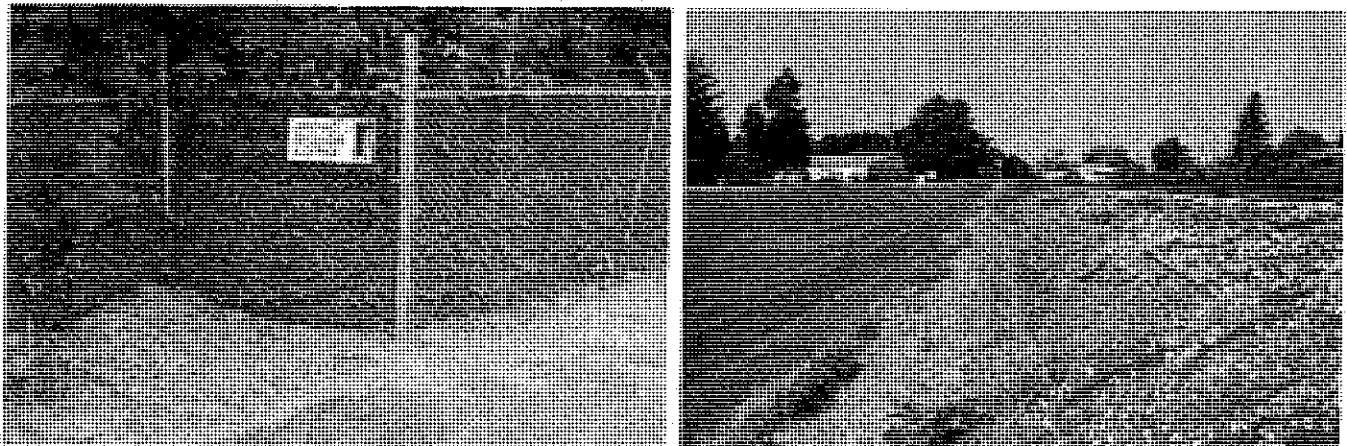
Figure 5. Examples of lines used as high-water marks at selected locations in the flooded area *A*, Seed line on buildings or trees. *B*, Mud lines on buildings. *C*, Debris lines on fence or ground.

High-water marks are an indication of the water level at peak stage of a river during a flood event. They can be used to determine the peak streamflow or to calibrate peak-flow models used to determine flood-inundation areas. High-water marks are usually determined from mud, seed, or debris lines (or a combination thereof) left behind as the floodwaters receded. Examples of seed, mud, and or debris lines that indicated water elevations for this flood are shown in figure 5. Trees are generally a good place to find high-water marks because seeds and small debris get caught in the bark. Several distinct lines can be left after an event as floodwaters recede. For example, a flood with a secondary peak or an upstream bank failure can leave a distinct debris or mud line below the actual peak high-water mark (right picture figure 5B). The accuracy of the high-water marks is subjectively rated by the USGS personnel locating the mark, as outlined in Lumia and others (1986). High-water marks can be rated “excellent” (within 0.02 ft of the true high-water mark), “good” (within 0.05 ft), “fair” (within 0.10 ft), or “poor” (greater than 0.10 ft).

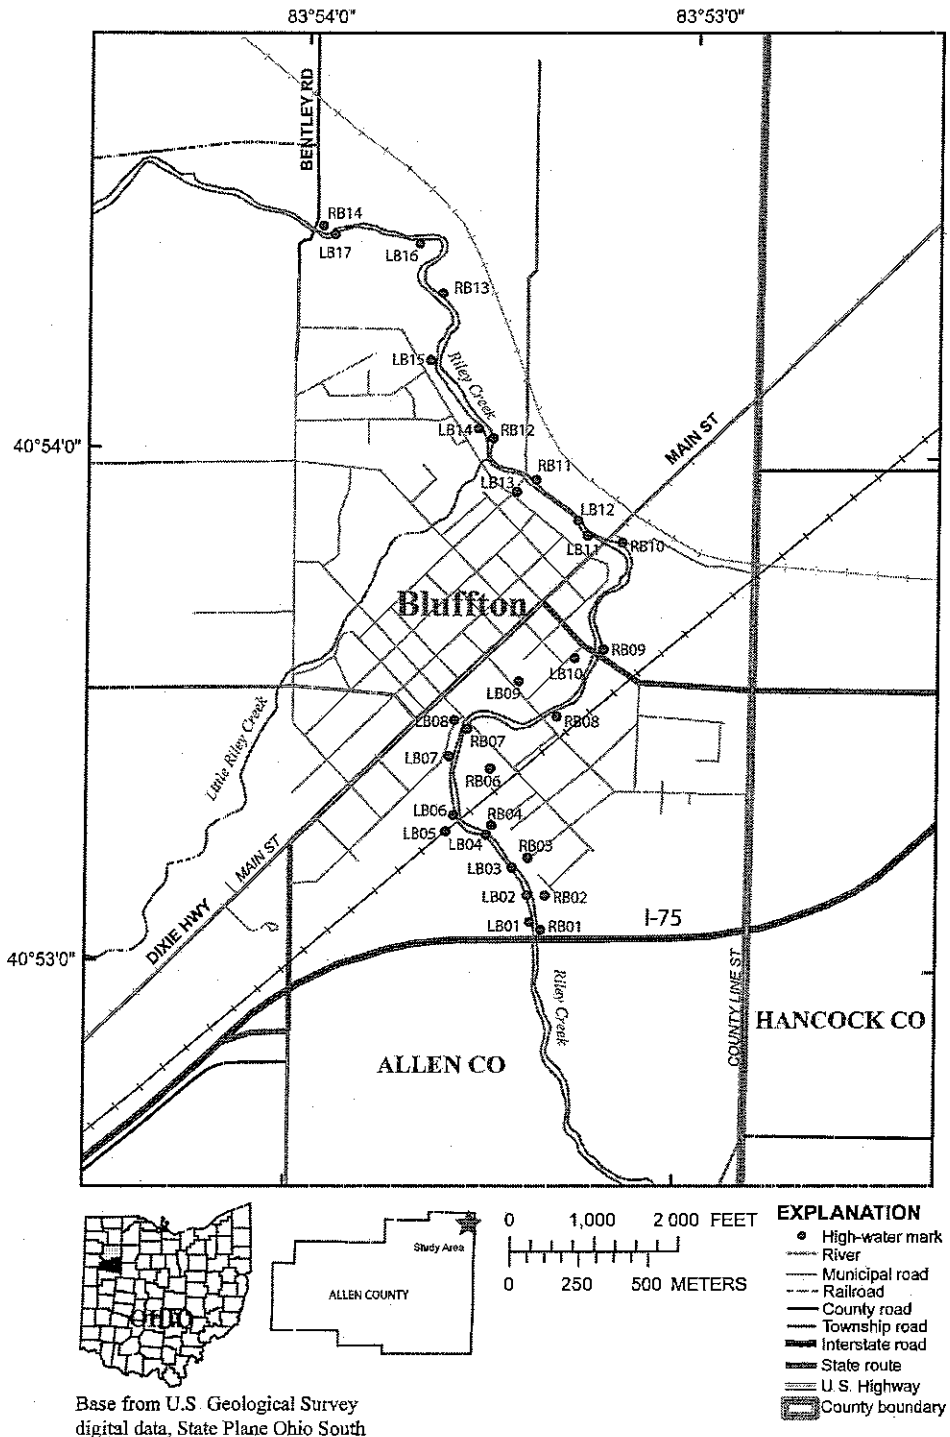
Figure 6. Locations of high-water marks along Riley Creek in and near the village of Bluffton, Ohio.

The USGS located and surveyed 421 high-water marks along approximately 44.5 mi of streams within the 9 communities flooded in this event (figs. 6–14, at back of report). All high-water marks (table 3, at back of report) were surveyed and referenced to the North American Vertical Datum of 1988 (NAVD 88) and the North American Datum 1983 (NAD 83). The elevations of the high-water marks were determined by use of a Global Positioning System (GPS) and differential leveling. The initial horizontal position of each mark was determined by handheld GPS units and then repositioned directly on aerial photographs in a Geographical Information System (GIS).

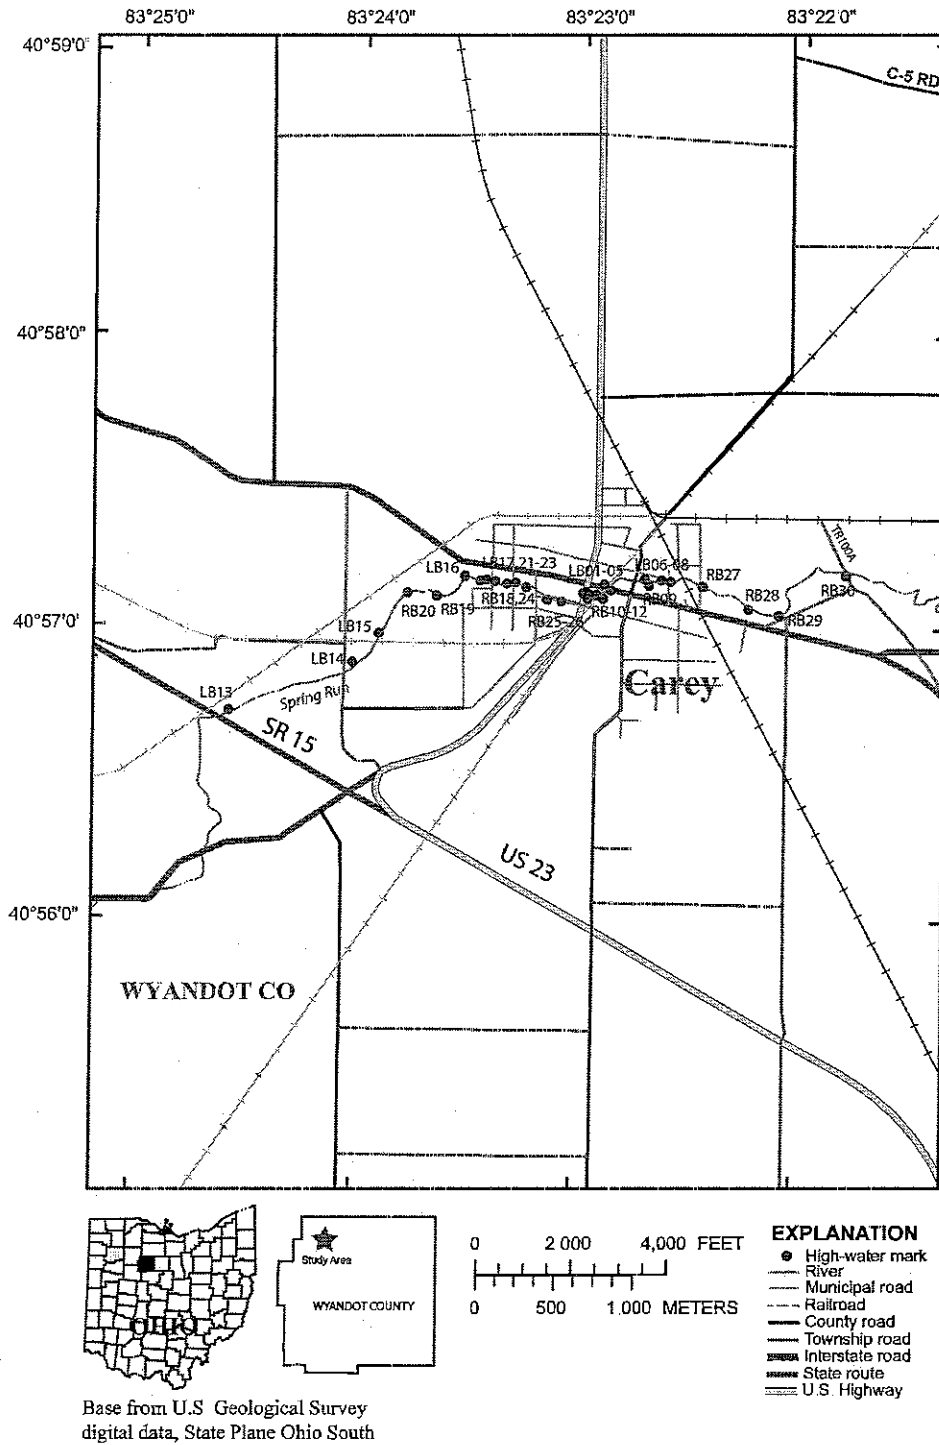
Figure 8. Locations of high-water marks along Spring Run in and near the village of Carey, Ohio.

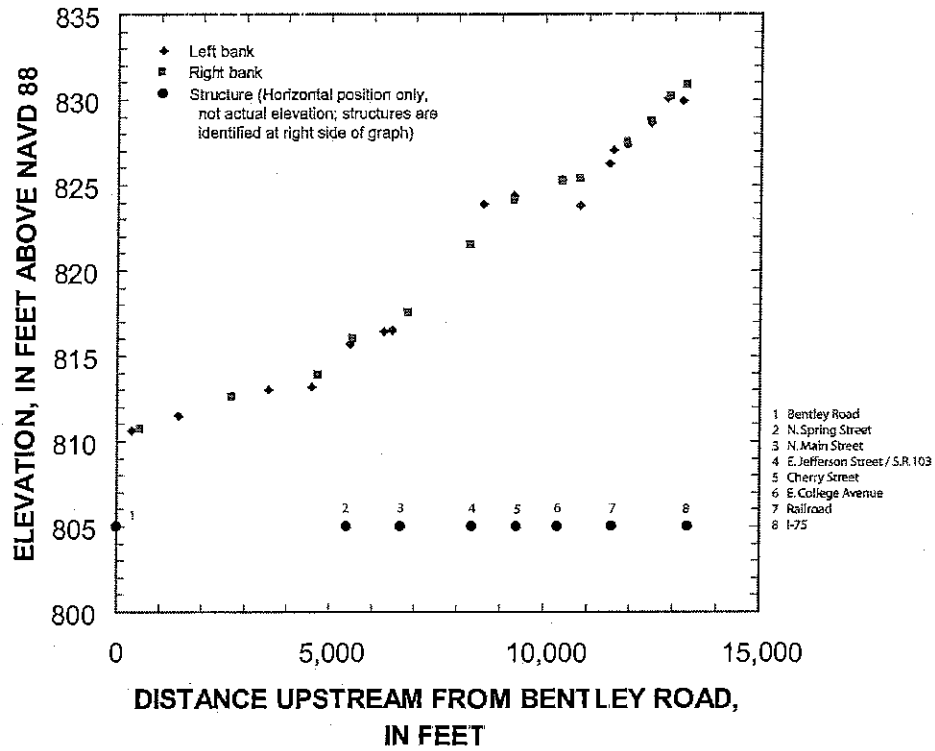
Figure 15. High-water-mark profile for Riley Creek in and near the village of Bluffton, Ohio.

To determine the high-water profile, a reference distance and elevation must be associated with each high-water mark. The reference distance is usually estimated by the distance along each stream's main channel from a selected location, usually the mouth or a bridge. Flood profiles were determined for each stream in the nine communities by this method (figs. 15–25, at back of report) except for the city of Ottawa. In and near Ottawa, the main channel of the Blanchard River has a high degree of meandering relative to the flood plain and, at several locations, the main-channel flow is against the general direction of the floodflow; therefore, the horizontal distance was estimated to align with the majority of the floodflow across the flood plain.

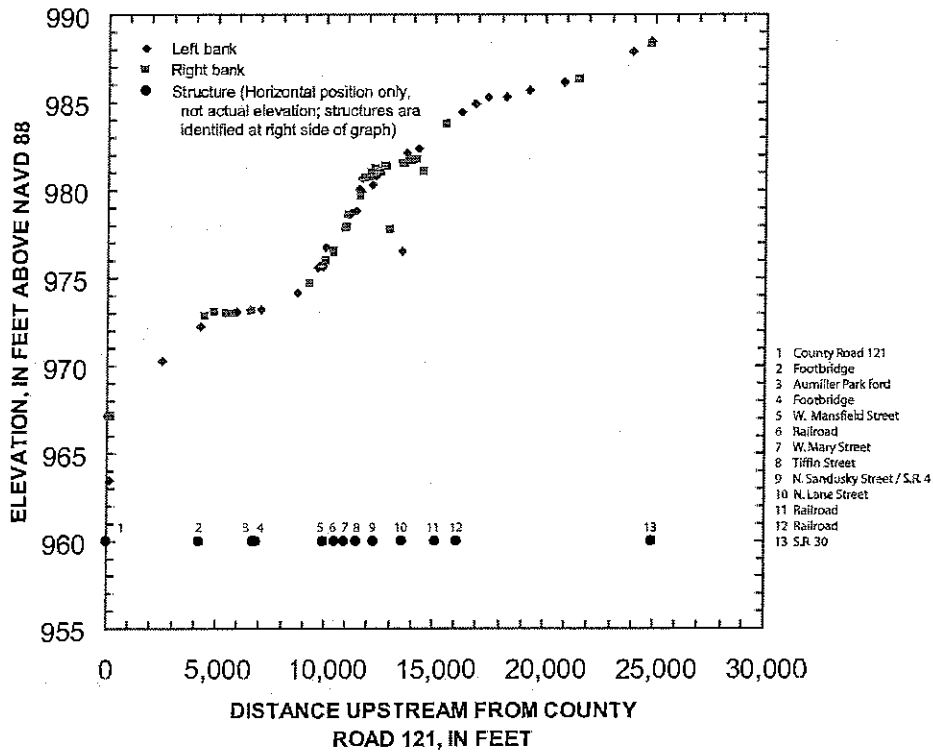
Figure 16. High-water-mark profile for the Sandusky River in and near the city of Bucyrus, Ohio.

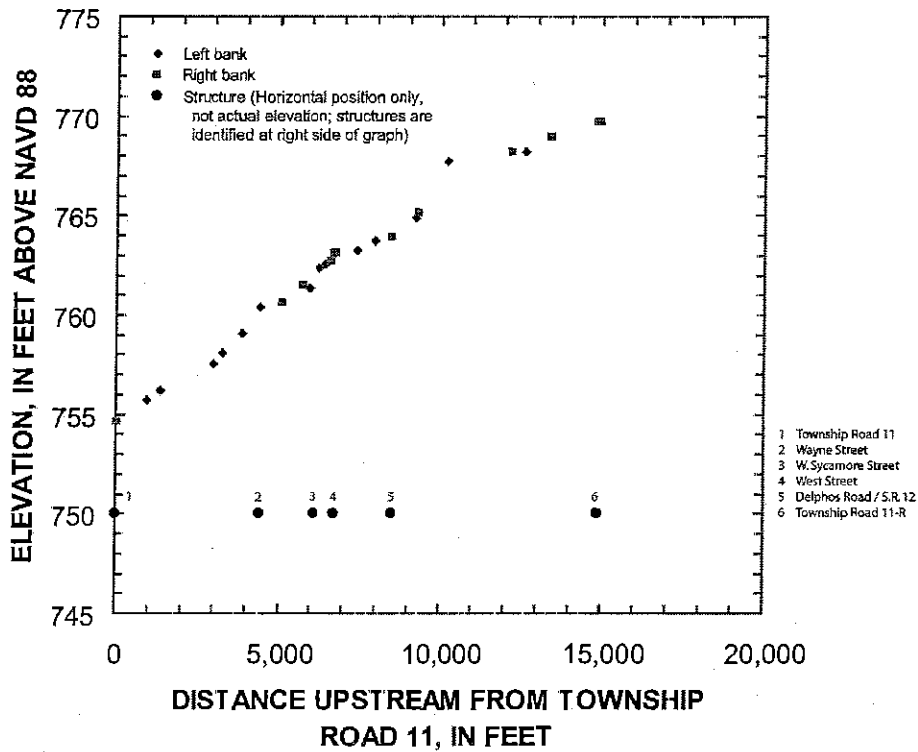
Figure 18. High-water-mark profile for Plum Creek in and near the village of Columbus Grove, Ohio.

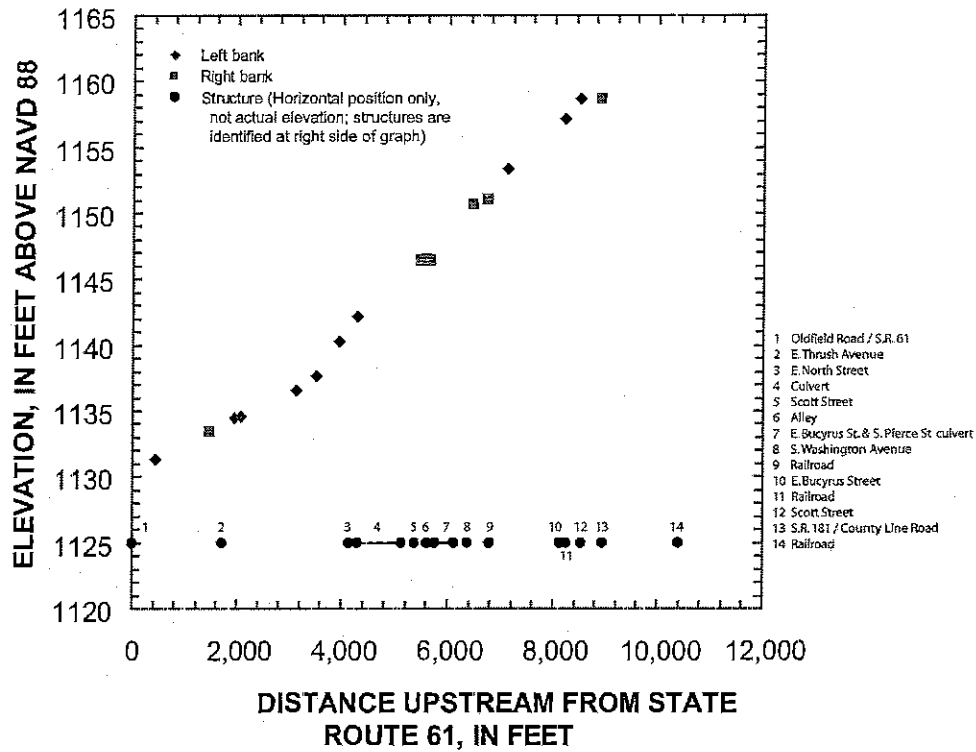
Figure 19. High-water-mark profile for the east unnamed tributary to Paramour Creek in and near the village of Crestline, Ohio.

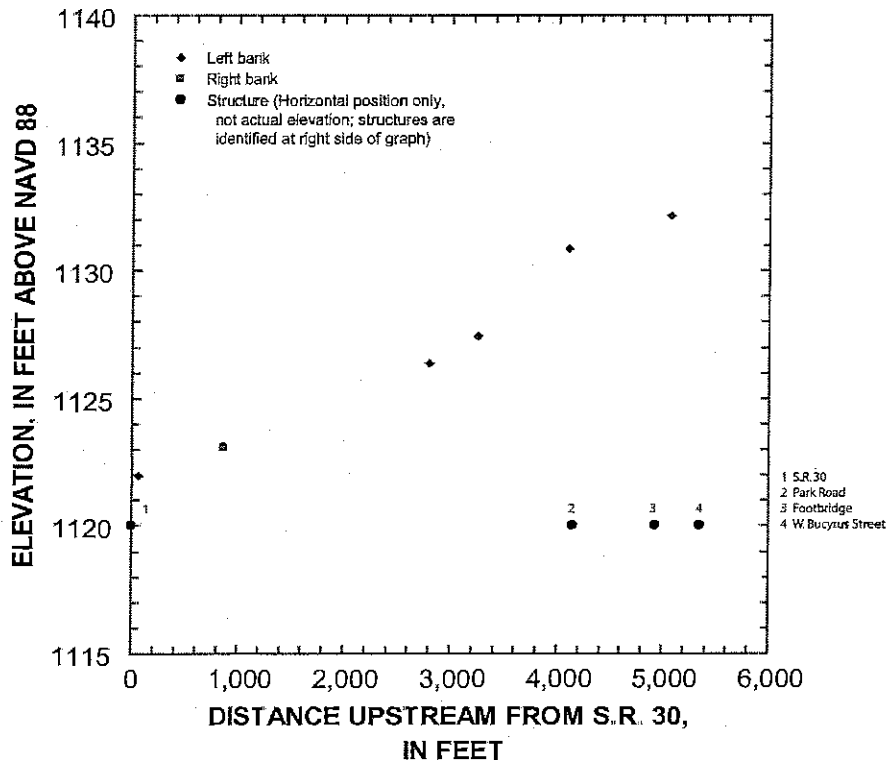
Figure 20. High-water-mark profile for the west unnamed tributary to Paramour Creek in and near the village of Crestline, Ohio.

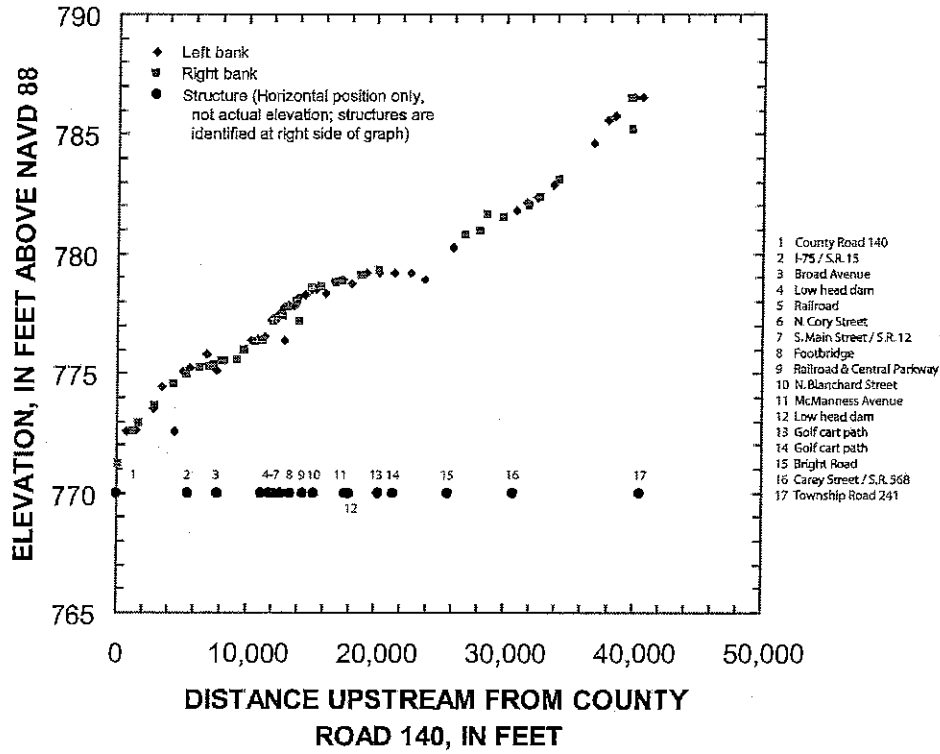
Figure 21. High-water-mark profile for the Blanchard River in and near the city of Findlay, Ohio.

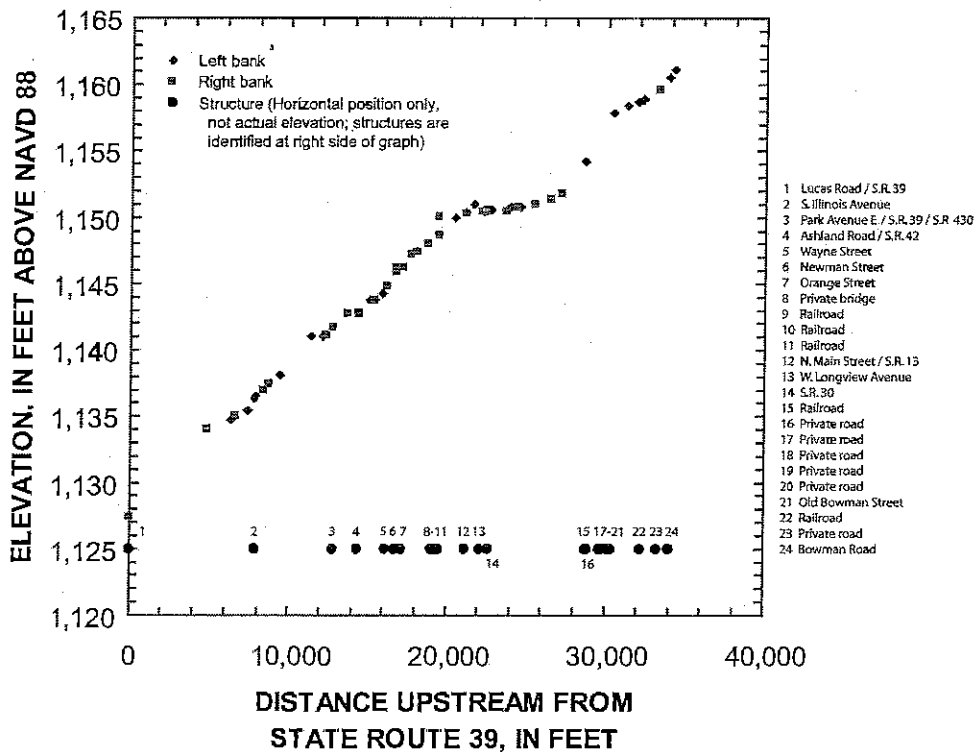
Figure 22. High-water-mark profile for the Rocky Fork Mohican River in and near the city of Mansfield, Ohio.

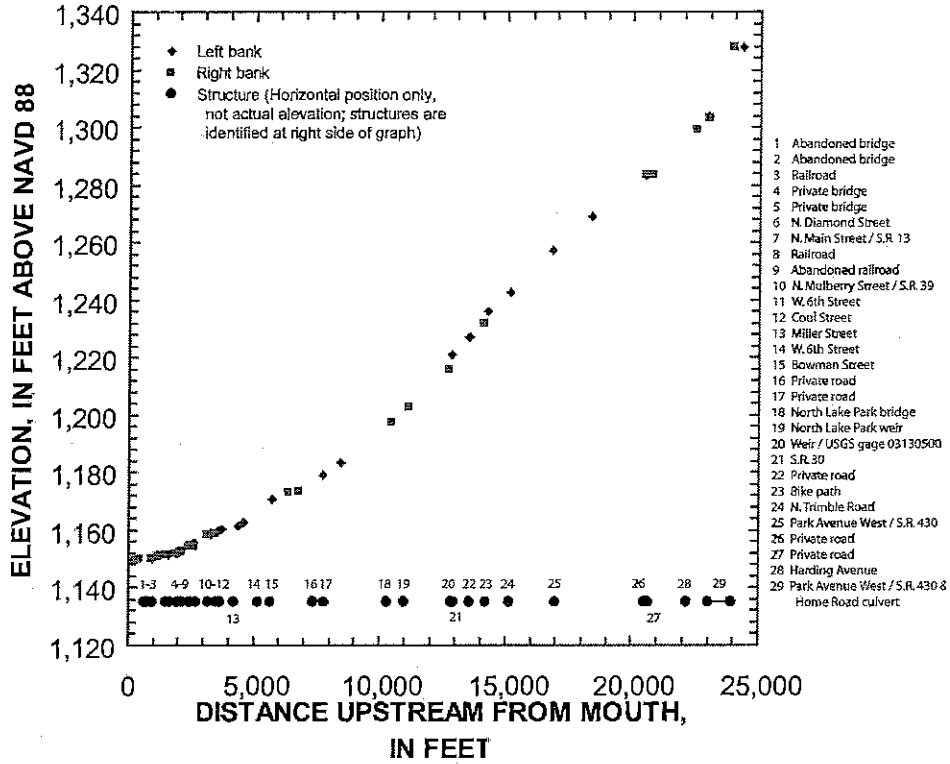
Figure 23. High-water-mark profile for Touby Run in and near the city of Mansfield, Ohio

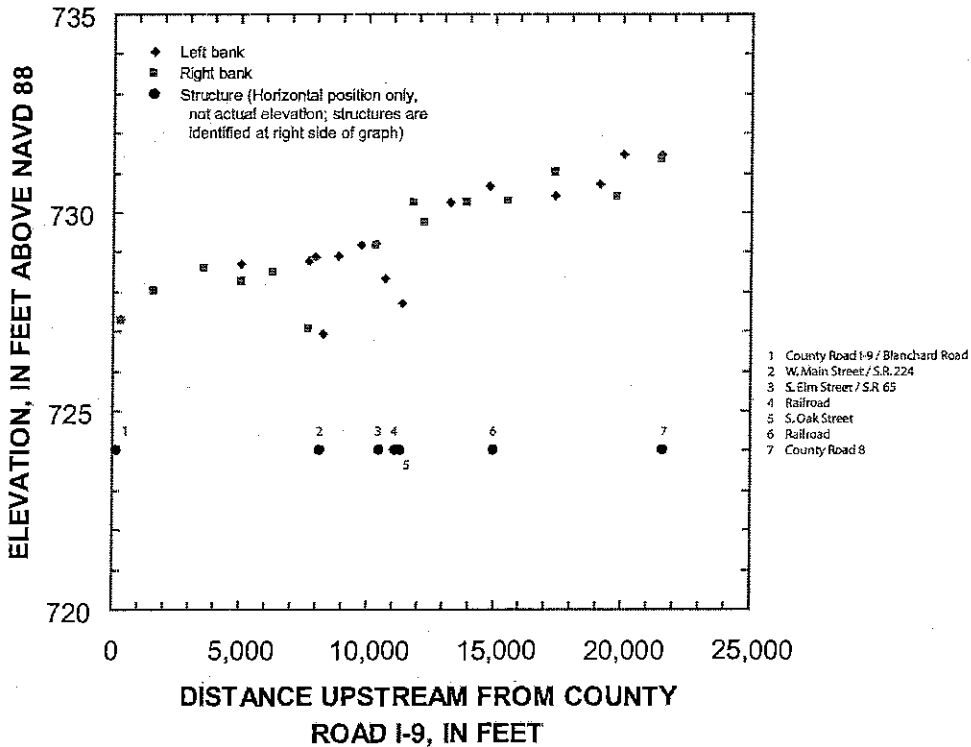
Figure 24. High-water-mark profile for the Blanchard River in and near the city of Ottawa, Ohio.

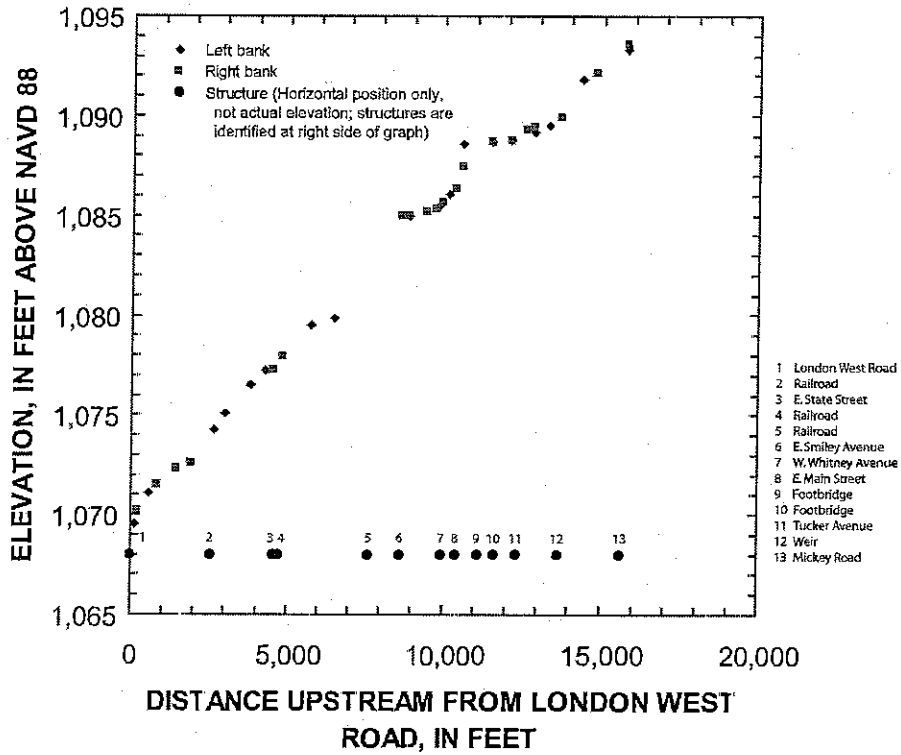
Figure 25. High-water-mark profile for the Black Fork Mohican River in and near the city of Shelby, Ohio
